VALUATION REPORT
Parcel
BARN CLOSE VICINITY
NEW PROVIDENCE, BAHAMAS

VALUATION REPORT: PARCEL, BARN CLOSE VICINITY, NEW PROVIDENCE

The captioned site comprises 5,004 square feet and accommodates a split-level townhouse with an area of 3,584 square feet.

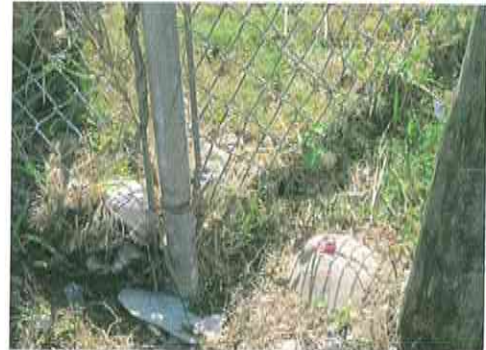
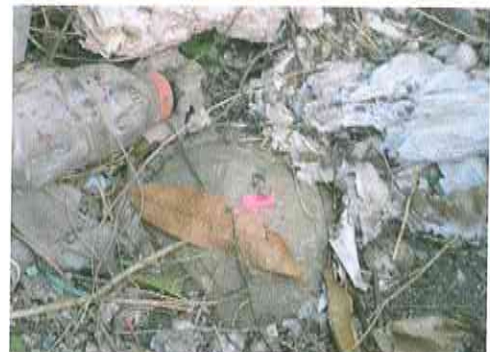
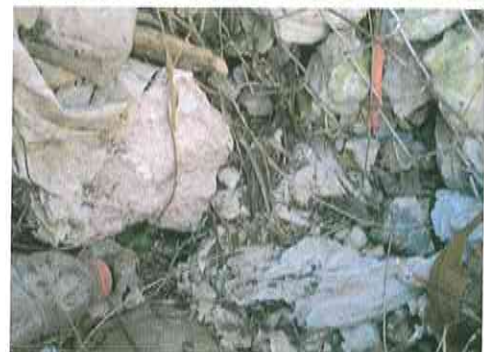
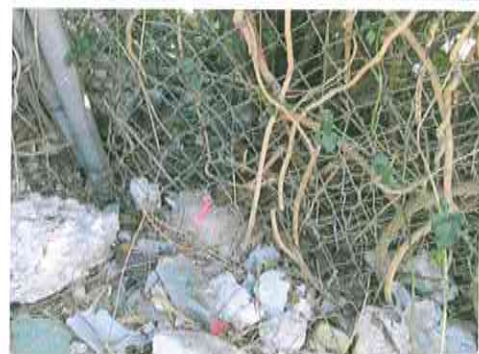
All permanent boundary stakes were visible at the time of inspection.

SURVEY MARKERS FOUND

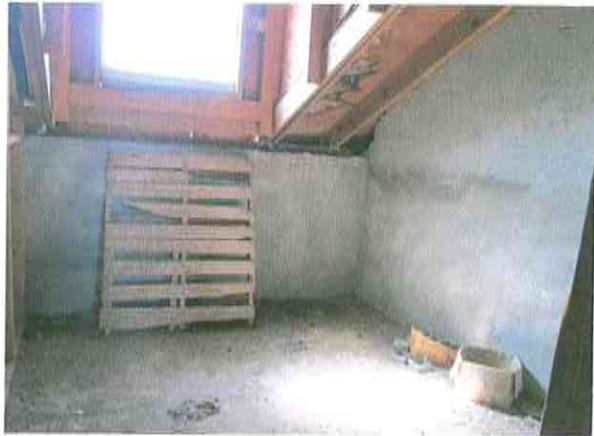
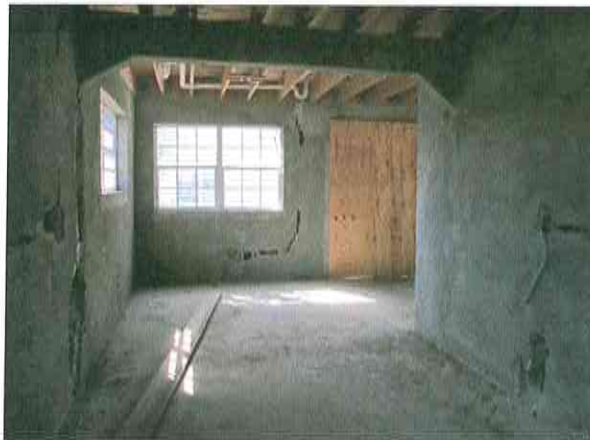
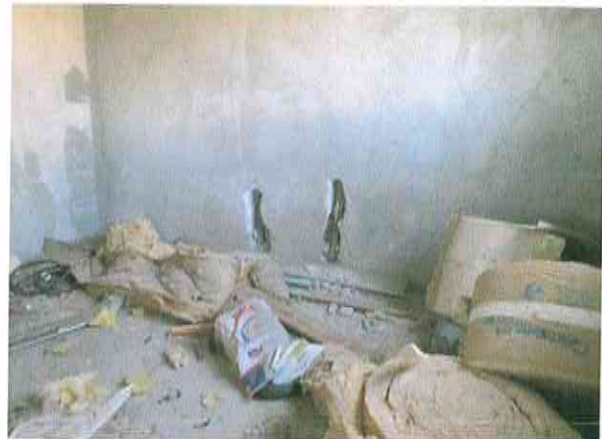
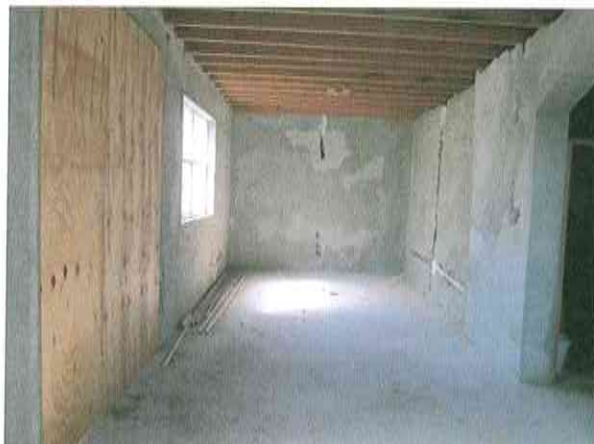
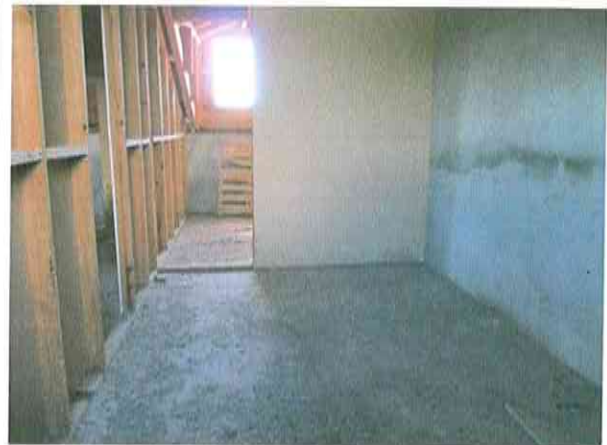
The construction of this building appears to be substandard and we recommend a structural survey to determine its structural integrity. Also, there are signs of water penetration at the dormer windows, and termite infestation. As a consequence, its effective age is about 20 years and a remaining economic life of about 30 years.

EASTERN UNIT
