## APPRAISAL REPORT

#### A SINGLE-FAMILY HOME

REGENCY PARK, UNIT 2A, LOT #10, FREEPORT, GRAND BAHAMA, BAHAMAS

# APPRAISAL REPORT FOR FIDELITY BANK OF A RESIDENTIAL BUILDING AT REGENCY PARK, UNIT 2A, LOT #10, FREEPORT, GRAND BAHAMA

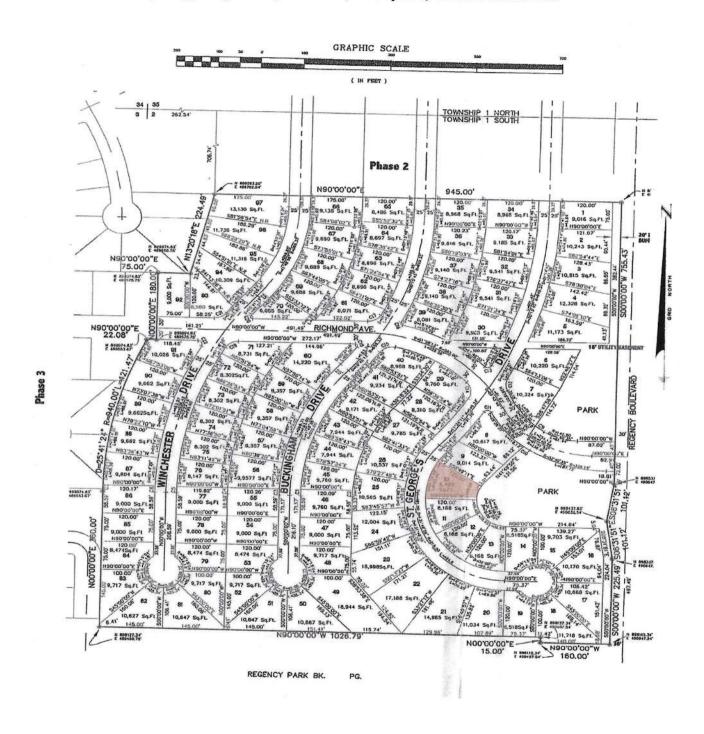
## Survey Plan of Subject Property Lot #10, Regency Park, Unit 2A, Freeport, Grand Bahama

said piece parcel or lot of land is delineated in the diagram or plat attached hereto and coloured pink.

The lot is generally flat and is rectangular in shape. The lot is bounded on the north by lot #9 running about 124 feet; on the east by the park running about 39.5 feet; on the south by lot #11 running about 123.7 feet; and the west boundary along St Georges' Drive running about 106.7 feet.

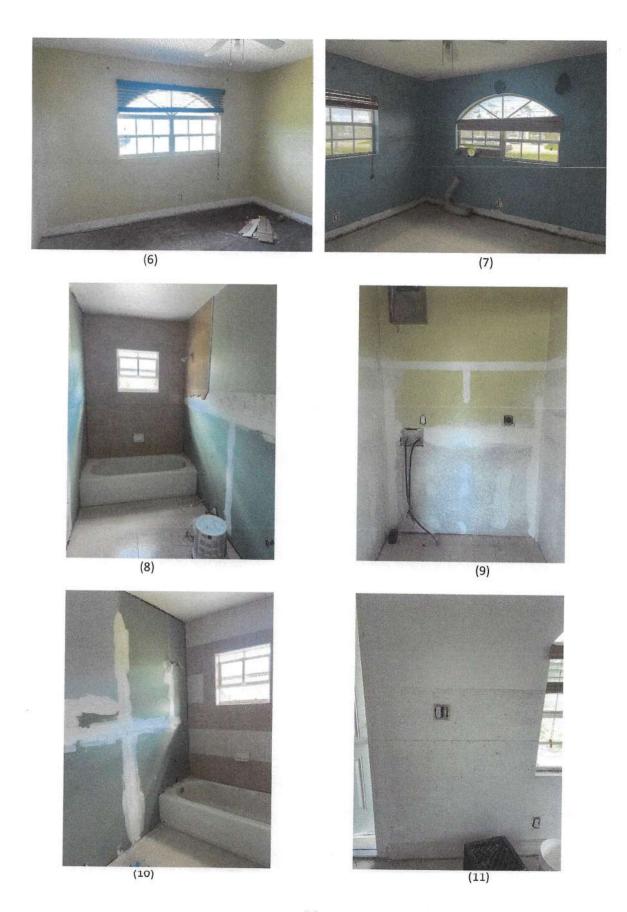
(3) Photographs of The Subject Property Interior

The house is in the process of being gutted and mold treatment necessary after Hurricane Dorian damages, with some 6' of salt water. The kitchen base cabinets have been removed and most of the sheetrock walls have been replaced and plastered. Both bathrooms have been gutted and the drywall has been replaced with mold-proof drywall and plastered.

The flooring throughout the house is covered with ceramic tiles. The walls are of sheetrock with hard coat plaster finish, and the ceilings are textured plaster finish on sheetrock.
